## **TEST REPORT**

An ad-hoc fire resistance test in general  
accordance with AS 1530.4-2014 Section 2  
and 12 of five pipe support systems protected  
by Product X.

44337600.1

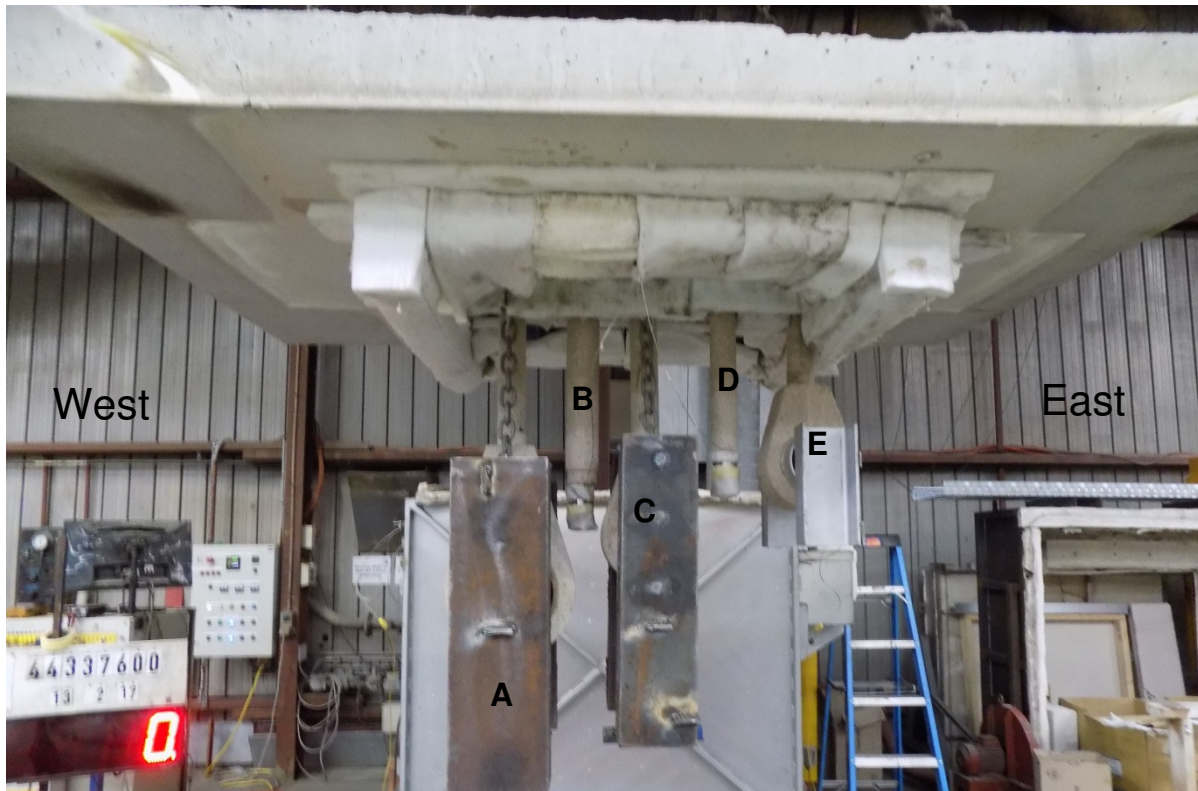
Figure A5.1: Exposed face (side view) of specimen before commencement of the fire-resistance test

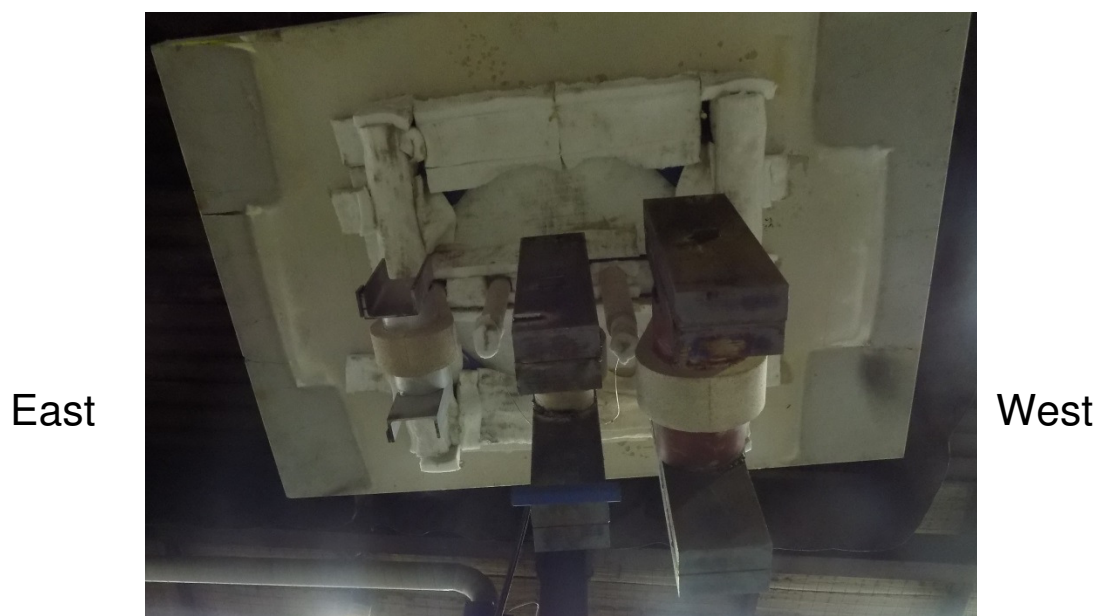
Figure A5.2: Exposed face (bottom view) of specimen before commencement of the fire-resistance test

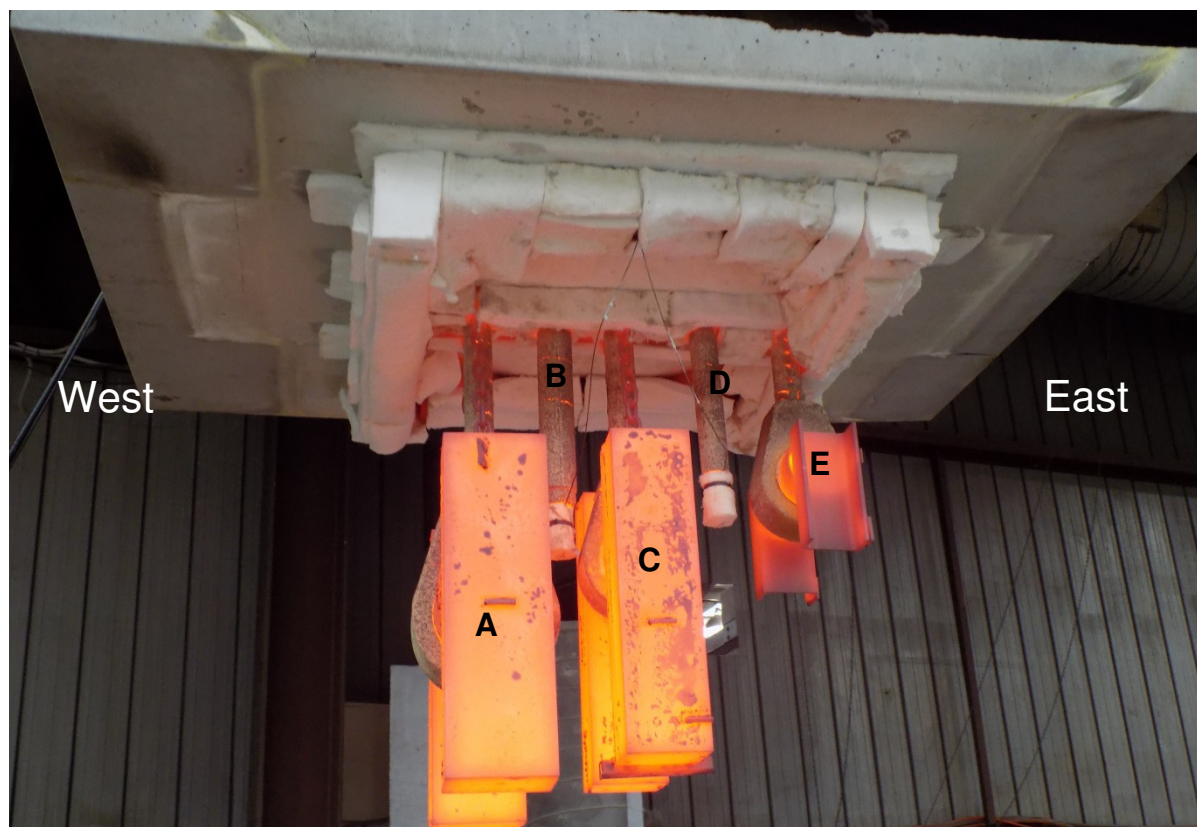
Figure A5.3: Exposed face (side view) of specimen at the end of the test.

- There appears to be cracks on the pipe support systems containing large masses.
- The three loaded specimens (A, C and E) continued to
